**ASSESSMENT OF  
EXISTING FLOOD PROTECTION  
IN UPSTREAM WATERSHEDS**

**CONNECTICUT RIVER BASIN  
SUPPLEMENTAL STUDY**

An Assessment of  
Existing Flood Protection  
in Upstream Watersheds

Phase 1 Report  
(1.1 D, 1.3 D, 1.3 E, 1.4 D)

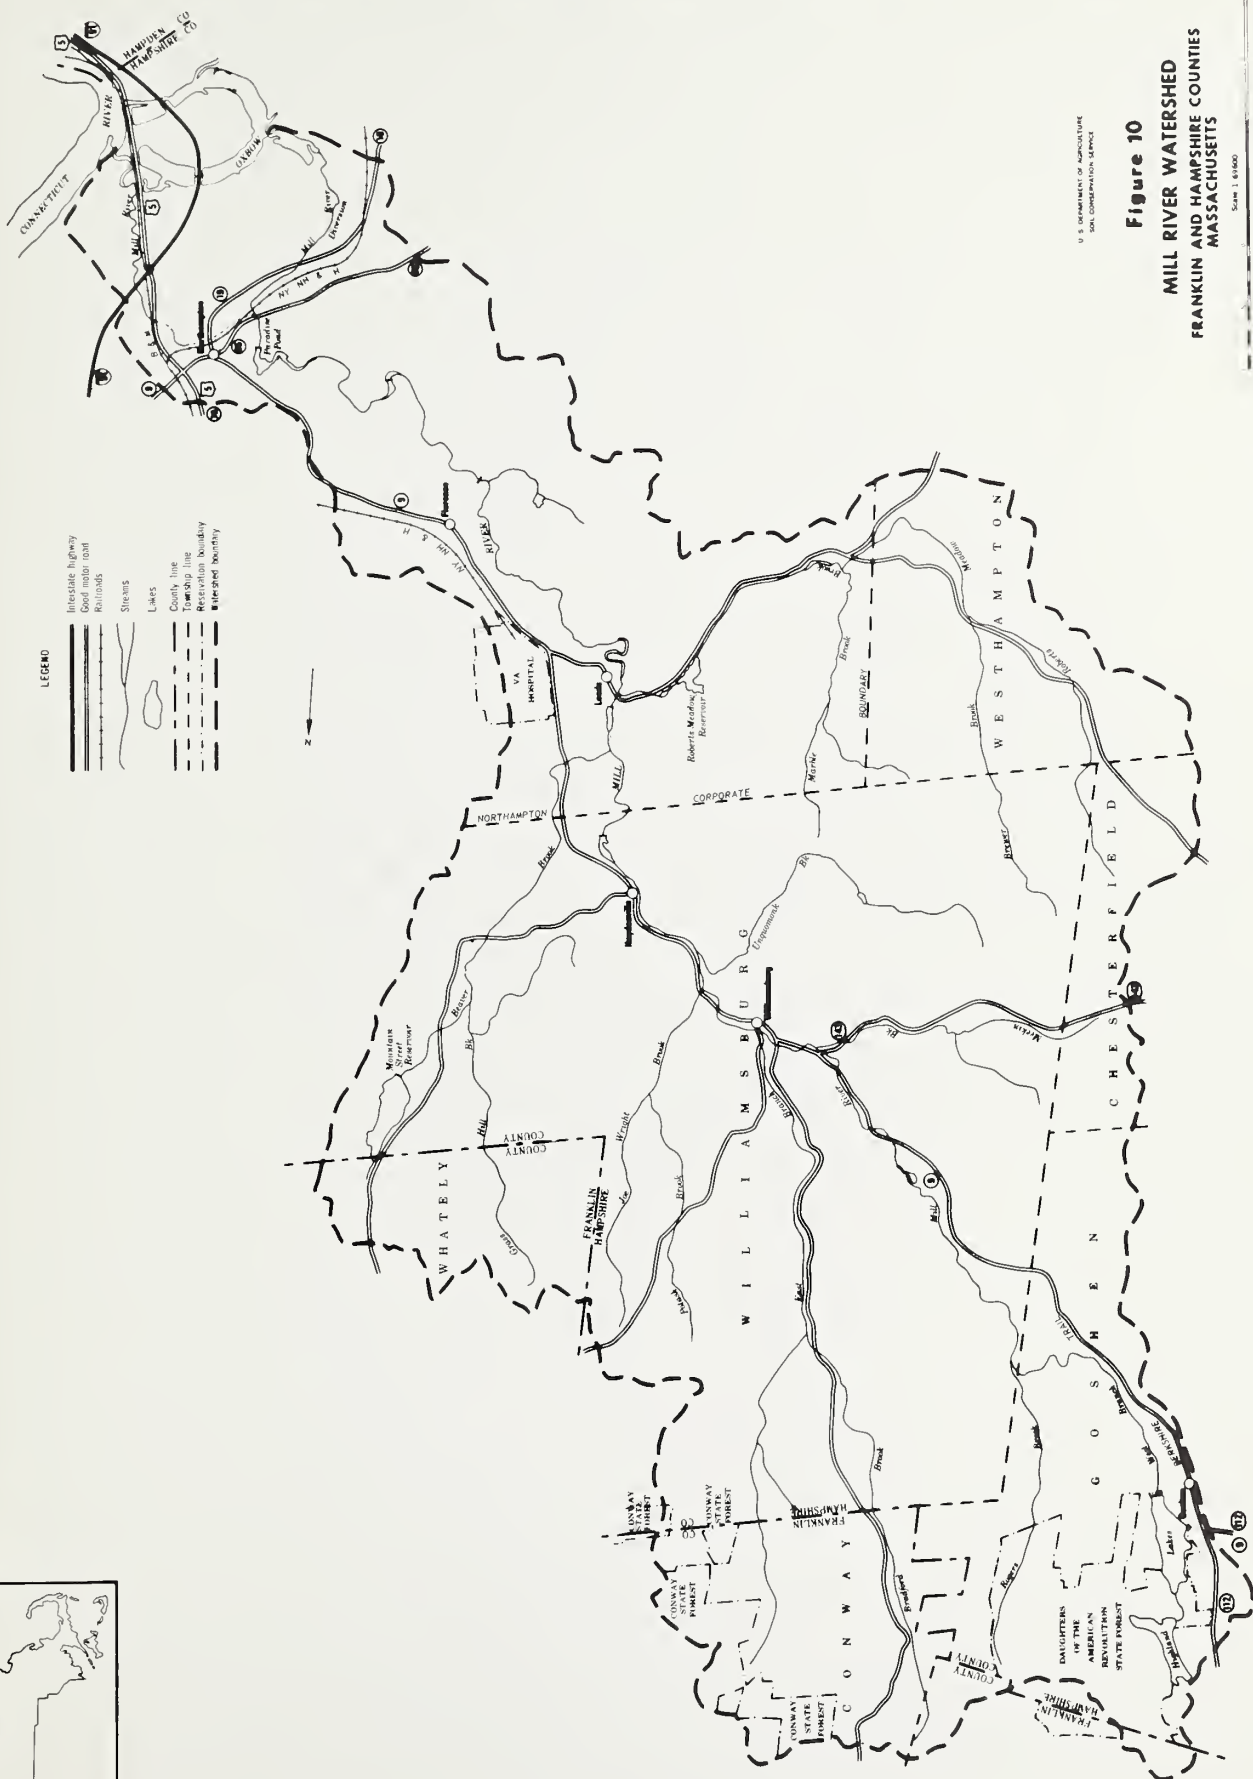
Figure 10

MILL RIVER WATERSHED  
FRANKLIN AND HAMPSHIRE COUNTIES  
MASSACHUSETTS

The Mill River watershed, shown in figure 10, is located in Hampshire and Franklin Counties in Massachusetts. The stream originates in the eastern part of the Berkshire Hills in the towns of Goshen and Conway. It flows through the town of Williamsburg and city of Northampton to its confluence with the Connecticut River at the Oxbow. Mill River was diverted from its original course at a point near Smith College in Northampton down to the Oxbow as a part of a local flood protection project completed in 1941 by the Corps of Engineers.
